**Flood Control Project Maintenance  
Levee Inspections**

**Maintenance Issue Types Only, Levee Inspection Report By Mile - Fall 2018**

**Reclamation District No. 2094 Walthall**

Waterway	Bank	Unit Miles	Inspection Start/End	Inspector
Unit No. 01 San Joaquin River	Right	2.78	11/09/2018 11/09/2018	Richard Willoughby

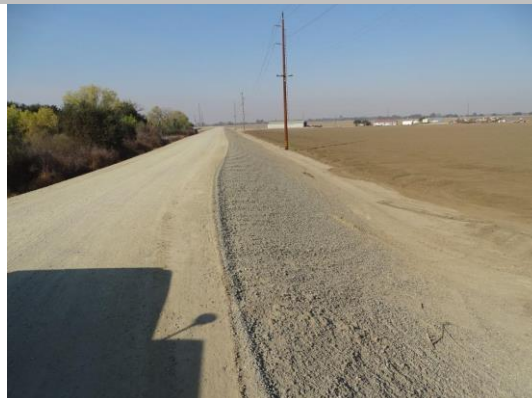
Photo 1 of 1 : FA\_2018\_RD2094\_320\_6\_20181119\_00016.jpg

LM Start	0.00	Rating **	A	Issue No.	6
LM End	2.79	Issue Type +	Ma	Location *	LS
Category	Earthen Levee			GPS Latitude/Longitude	
				Start	End
Item	Vegetation			37.771832 °	37.749470 °
				-121.298378 °	-121.288885 °
DWR ID	DWR_RD2094_01_f_2018_6				
Comment Code					
V1 : Control annual grass and weeds on the levee slopes and easements.					
Inspector Comment

Looking at typical view of landward slope. (Fall 2018)

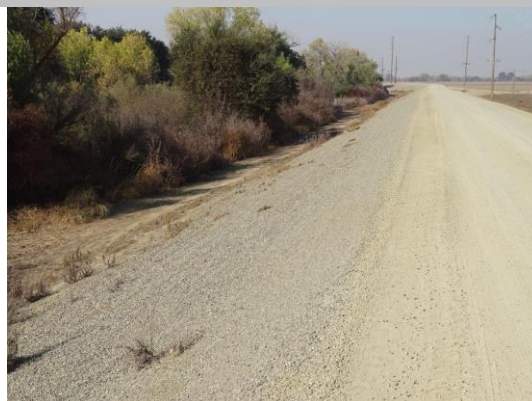
Photo 1 of 1 : FA\_2018\_RD2094\_320\_7\_20181119\_00015.jpg

LM Start	0.00	Rating **	A	Issue No.	7
LM End	2.79	Issue Type +	Ma	Location *	WS
Category	Earthen Levee			GPS Latitude/Longitude	
				Start	End
Item	Vegetation			37.771832 °	37.749470 °
				-121.298378 °	-121.288885 °
DWR ID	DWR_RD2094_01_f_2018_7				
Comment Code					
V1 : Control annual grass and weeds on the levee slopes and easements.					
Inspector Comment

Looking at typical view of waterward slope. (Fall 2018)

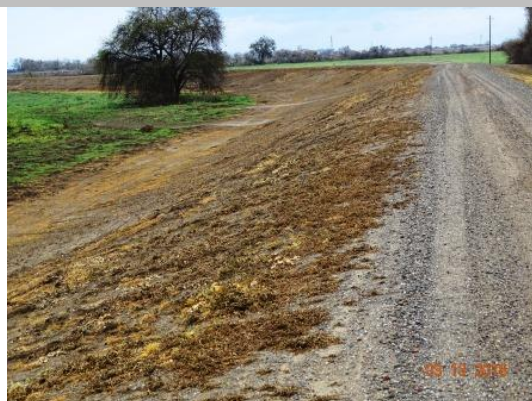
Photo 1 of 1 : FA\_2018\_RD2094\_321\_1\_20181127\_00001.jpg

LM Start	0.08	Rating **	A	Issue No.	1
LM End	0.42	Issue Type +	Ma	Location *	WS
Category	Earthen Levee			GPS Latitude/Longitude	
				Start	End
Item	Vegetation			37.759842°	37.760621°
				-121.300809°	-121.306804°
DWR ID	DWR_RD2094_02_f_2018_1				
Comment Code					
V1 : Control annual grass and weeds on the levee slopes and easements.					
Inspector Comment					
Acceptable vegetation control.

View of the acceptable vegetation control on the levee slope.
